# In-situ management

*The "other" approach to remediating  
contaminated sediments*

SAO Environmental Consulting AB

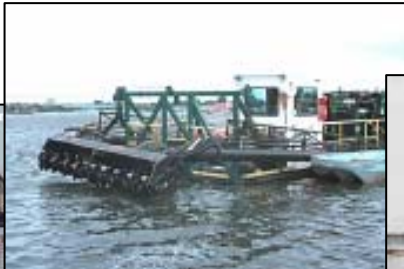
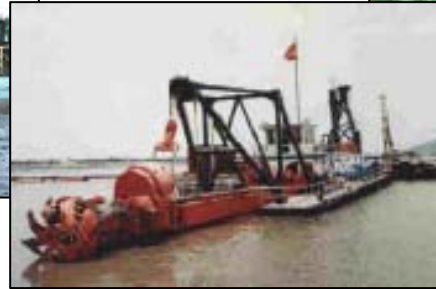
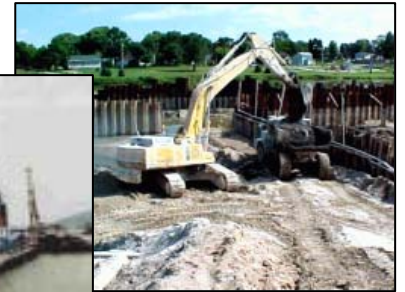
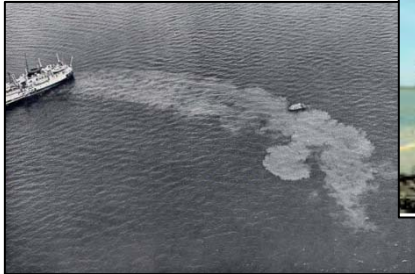
Figure 42: Cleanup Dredging at Saginaw River

Removing contaminated sediment by dredging or excavation, followed by transport and disposal (with/without pre-treatment of sediment and/or water phases)

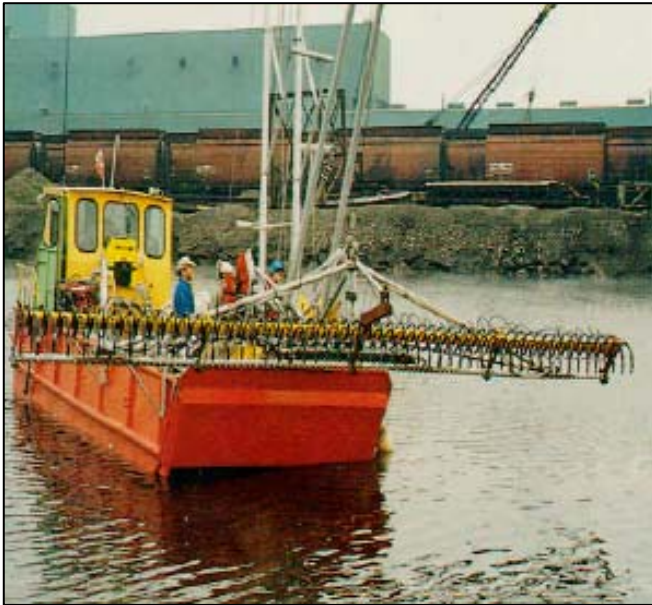
Placing treatment agents into or overtop contaminated sediment to reduce COC mass, toxicity and/or bioavailability within the sediment's biological zone.

- Inject agents *into* sediment mass
- Mechanically mix in

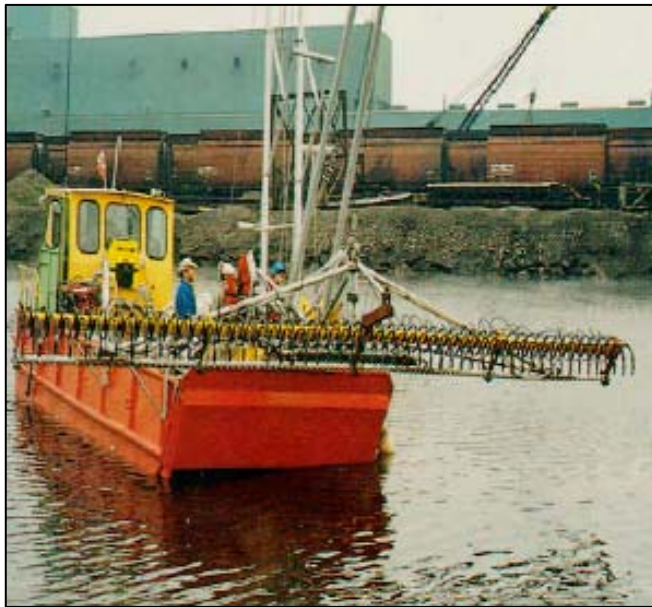
- Inject agents *into* sediment mass
- Mechanically mix in
